Re: 19-20-10MO – Roofing – Addendum #1

Subject: Commercial Structure Asbestos Survey
Nueva Vista High School Permanent Building Roofs
Infotox, Inc. Project # 202052

Asbestos Survey Report Photographs

Rubidoux High School, Building 1400, 1500, 1600, 1700 Roofs

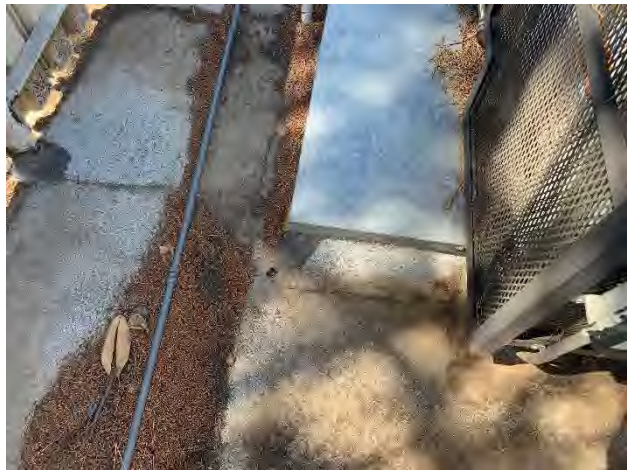
PHOTO # 4
Sample(s): NV-06

0	NV-06	ROOF MASTIC	ND	0.00	GOOD	SPECIAL	LOW	COLLECTED FROM ROOF 13 @ HVAC EQUIP PAD. APPEARS TYPICAL OF -03 MASTIC
0	NV-07	ROOF MATERIAL	ND	0.00	GOOD	SPECIAL	LOW	COLLECTED FROM ROOF 12 @ WEST END. TYPICAL OF -01 & -04
0	NV-08	ROOFING FELT	ND	0.00	GOOD	SPECIAL	LOW	COLLECTED FROM ROOF 12 UNDER -07 ROOFING. TYPICAL OF -02 & -05
0	NV-09	ROOF MASTIC	ND	0.00	GOOD	SPECIAL	LOW	COLLECTED FROM ROOF 12 @ HVAC SCREEN POST. APPEARS TYPICAL OF -03,-06
0	NV-10	ROOF MASTIC	ND	0.00	GOOD	SPECIAL	LOW	COLLECTED FROM ROOF 12 @ HVAC DUCT WALL PENETRATION. APPEARS TYPICAL OF -03,-06,-09

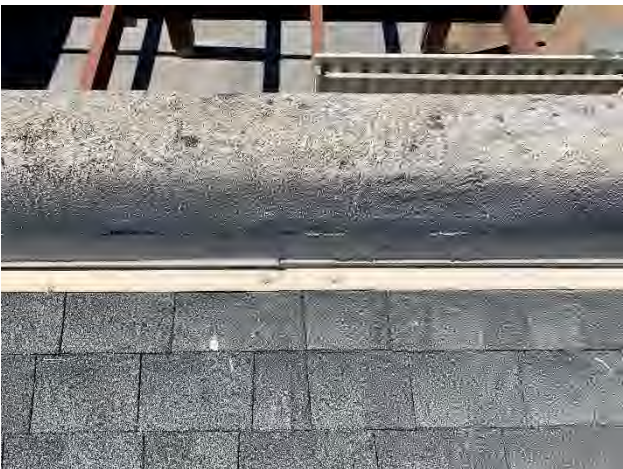
<p style="text-align: center;">Not Used</p>	<p style="text-align: center;">Not Used</p>
<p style="text-align: center;">PHOTO # 16 Sample(s): NV-27</p>	<p style="text-align: center;">PHOTO # 17 Sample(s): NV-</p>	<p style="text-align: center;">PHOTO # 18 Sample(s): NV-</p>
